# Eemdijk full-scale field test programme: sheet pile pullover tests

## TProgramme d'essai terrain à taille réelle Eemdijk : essais de déformation et de rupture de murs palplanches

**ABSTRACT:** Dikes in the Netherlands have traditionally been constructed with soil. Climate change and subsidence requires heightening and or reinforcing of these existing ground dikes. Traditional reinforcements demand additional space, which in some cases conflicts with existing buildings. Applying sheet pile walls in dikes allows for strengthening while minimizing the increase in footprint. However, a validated design approach that complies with relevant regulations lacks. To enable the validation of a proposed design approach, a full-scale field test programme (Eemdijkproef) was performed near the town of Eemdijk, The Netherlands. It consisted of a step wise approach: 1) sheet pile pullover tests, 2) ground dike stability test, 3) sheet pile dike stability test. All tests were loaded until failure occurred. The full-scale pullover tests (POT) consisted of 4 sheet pile configurations. The length of the sheet piles varies between 13 and 16m and the width of the panel varies between 1.8 and 4.2m. Bo

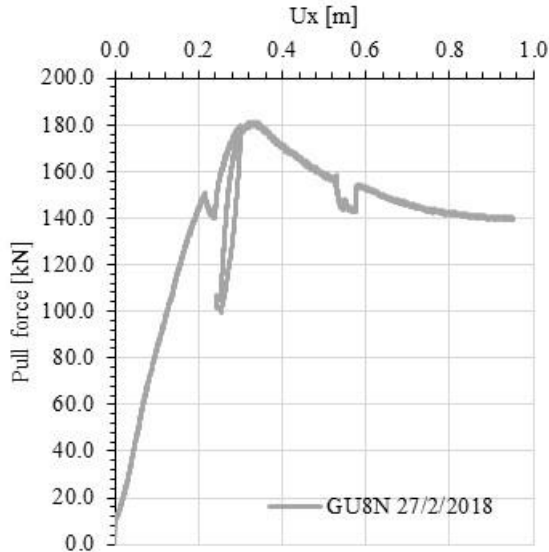
Figure 6. Force-displacement diagram GU8N.  
GU8N 2018-02-27 12:47:00

The maximum pulling force reached during this test is 180kN. The fixation level where rotation starts is about -2.0m NAP. Upon reaching 30cm of displacement the SAAF's on the sheet pile wall are removed to prevent any damage due to local buckling of the sheet pile. For this the pull-force is temporary lowered to 100kN. A similar procedure is also followed for the other tests. The obtained force-displacement diagram for the GU8N is shown in figure 6. In figure 7 the horizontal displacements measured by the SAAF and prisms are plotted just before removal of the SAAF. In this figure the SAAF's in front of the wall are also shown with an offset of 1m, in reality they are placed at 0.3m distance of the center-line of the sheet pile wall.

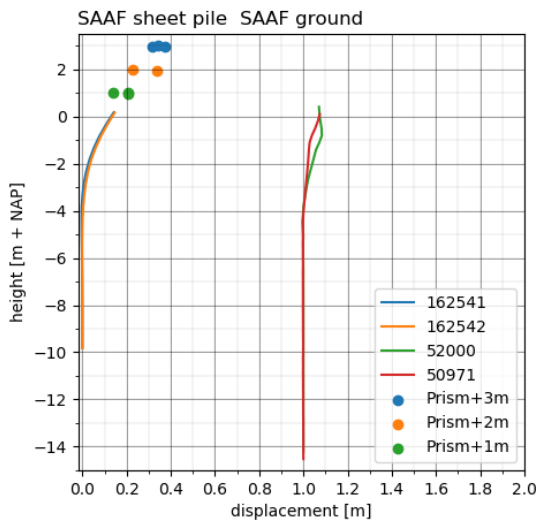
Figure 7. Horizontal displacements over depth of the SAAF and prisms at the GU8N sheet pile.

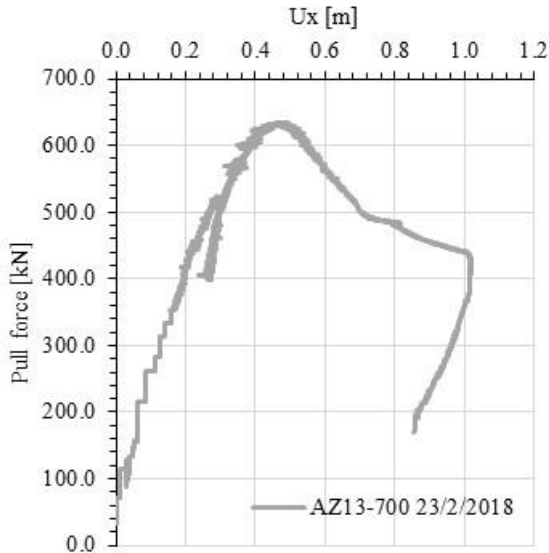
Figure 10. Force-displacement diagram AZ13-700  
AZ13-700 2018-02-23 14:04:00

triple-U, the maximum pulling force is also higher at 634kN (figure 10). The AZ13-700 three double-Z profile is stiffer than the GU8N profile. This is also reflected in horizontal displacements (figure 11). The fixation level where rotation starts is about -4.0m NAP due to the higher stiffness.

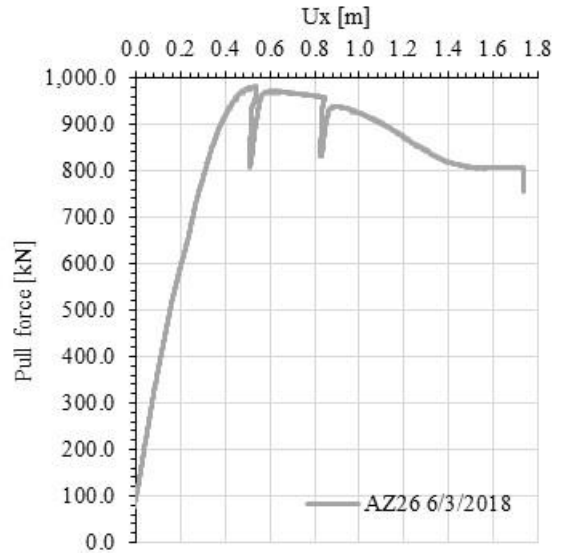
Figure 12. Force-displacement diagram AZ26  
AZ26 2018-03-06 12:34:00

The AZ26 three double-Z is the strongest profile that has been tested as part of the pullover test program, a maximum pull-force of 982kN is reached. The fixation level where rotation starts

is about -6.0m NAP due to the high stiffness. The results in figure 12 also show that after reaching the maximum pull-force this profile allows for large additional displacements with little reduction of the pulling force relative to the other tested profiles. This setup of three double heavier profiles represents also the typical configuration

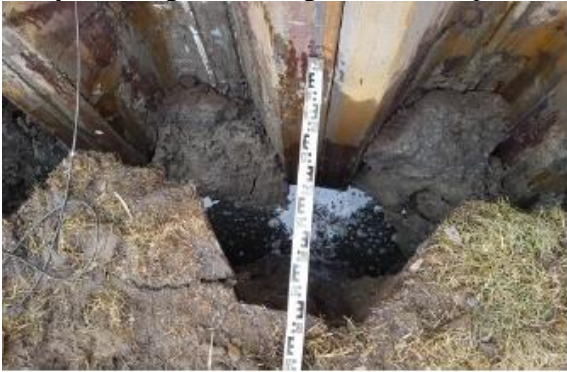
Figure 16. Gapping behind sheet pile wall AZ26

During the pullover test the sheet piles are pulled forward resulting in a gap at the back of the sheet pile wall. Due to the undrained behavior of the cohesive soil the soil remains almost perfectly vertical and the water level in this gap drops significantly below the original water table effectively reducing the loading on the sheet pile.
