Boa Nova Teahouse and Restaurant Leça da Palmeira, Matosinhos, Portugal 1958–1963 Architect: Alvaro Siza

Mota, N. (2019). Boa Nova Teahouse and Restaurant Leça da Palmeira, Matosinhos, Portugal 1958–1963: Architect: Alvaro Siza. In F. Bollerey, & C. Grafe (Eds.), *Restaurants and Dining Rooms* (pp. 281-287). (Interior Architecture). Routledge - Taylor & Francis Group. https://doi.org/10.4324/9780203013656

15 Boa Nova Teahouse and Restaurant Leça da Palmeira, Matosinhos, Portugal 1958–1963 Architect: Álvaro Siza

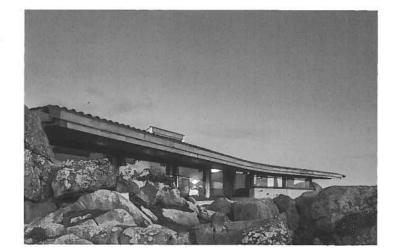
Boa Nova, viewed from the beach.
Photo: Joao Morgado

building comprises three flights of U-shaped steps. These create a promenade architecturale that dramatically filters the transition between arrival by car and the act of entering the building. The client is guided along an ascending pathway towards the entrance of the restaurant and, as he heads into the building, so to speak, he is also treated to expansive views of the ocean. The plasticity of the white walls that border the steps are delimited by the horizon and abruptly countered by the low ceiling of a porch finished with rough boards made out of red Afzelia wood (Fig. 1, Fig. 2, Fig. 3).

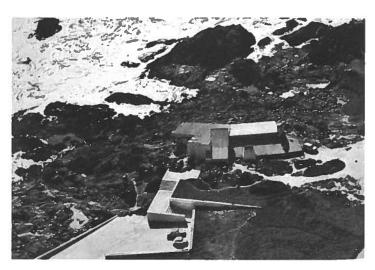
Aerial view of Boa Nova teahouse and its surroundings.

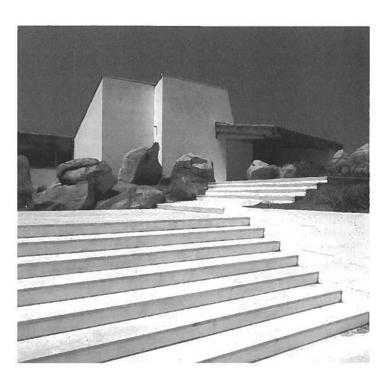
Entrance view. Photo: Joao Morgado including business and leisure clients, as well as those in search of a gastronomic experience (Fig. 4, Fig. 5, Fig. 6).

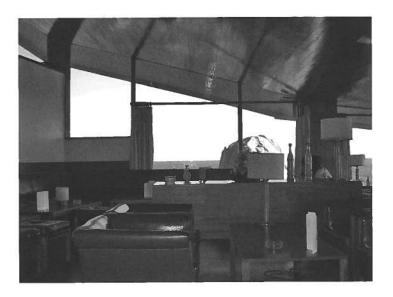
Interior view of the tea room. Framed view of the beach rocks from the dining room. Dining room interior.

The tearoom is roughly square-shaped and the stepped openings at the south façade reveal views of the rocks against which the building is built. In the restaurant, a large window that runs down the longest side of the room frames the ocean view to the west. At the Boa Nova teahouse and restaurant, the boundary between exterior and interior appears to dissolve. This effect is further heightened by the large span of the roof that projects over these windows and creates an intense relationship with the dramatic landscape surrounding the restaurant.

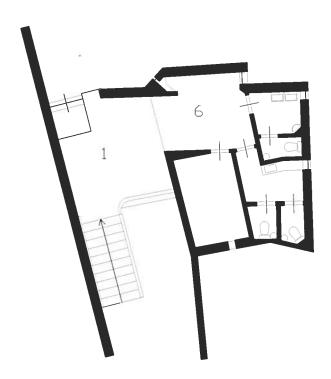
Entrance level plan, Boanova.

Inside the building, there is an entrance lobby with a cloakroom and toilet. At this level, the client is able to see the distant horizon through the skylight that pierces the inclined roof of the stairwell. At the bottom, a floor-to-ceiling opening frames the view towards the rocks. The presence of the sea is conspicuously avoided here, and it is only rediscovered as the client descends the stairs.

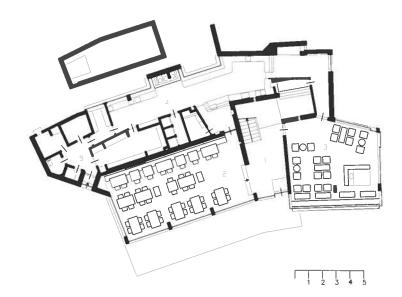
Restaurant level plan, Boanova.

Downstairs, the public area is split between the tearoom and the restaurant. The division of the programme into two different rooms allows the spaces in the building to operate continuously and independently of one another throughout the day, rather than just at specific lunch and dinner periods. It also helps the venue attract a wider range of clientele,

The service area is a long and partially sunken covered walkway that stretches behind the public rooms. A continuous horizontal window on the north side, which emphasises the fact that the roof is detached from the retaining walls, allows light into the space. Roughly the same size as the public rooms, it articulates the building in terms of both its functional organisation and layout, and also in terms of its relationship with the challenging topography. Next to the kitchen, further partitions were created within the service area, including a bedroom, dressing room, cellar and several storage rooms. The service area connects independently with both the tearoom and the dining room, thus avoiding interference between service circulation and the public *promenade*. It has, moreover, a discreet independent connection to the exterior in the north side of the building.
